PERMEABILITY OF BITUMINOUS MIXTURES EVALUATION OF PAVEMENT DISTRESS

Shahab Khanzada, *Pavement Specialist, National Highway Authority, Pakistan*
pavexpert@yahoo.com

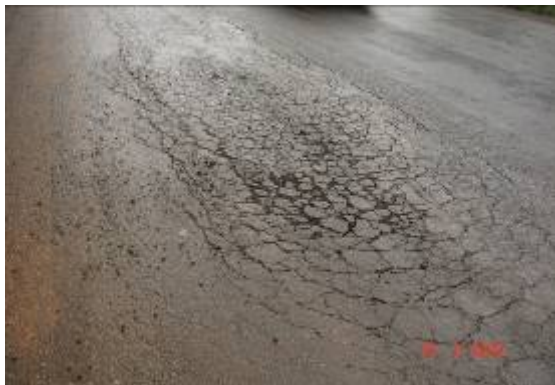
Figure 1: Intense cracking of the asphalt layer

A visual inspection was carried out to record the various types of distresses which had appeared on the surface of the pavement. The distresses recorded included hairline cracks, alligator cracks, shoving, raveling, etc. It was also noticed that pot holes had started developing at the severely cracked areas. Some areas also showed signs of depression. There were no signs of bleeding or rutting on the pavement. The majority of the distresses were confined to the left hand wheel path of the slow lane. In the sections where the pavement had totally failed the distresses started from the slow lane and then progressed to the fast (inner) lane, which mostly cater for fast moving vehicles with low axle loadings. (see Figures 1 and 2 below): [2]

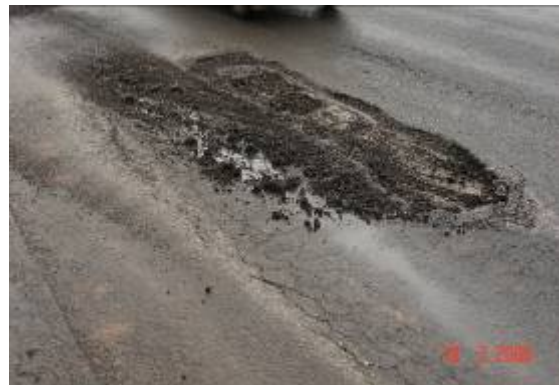
Figure 2: cracking followed by raveling.

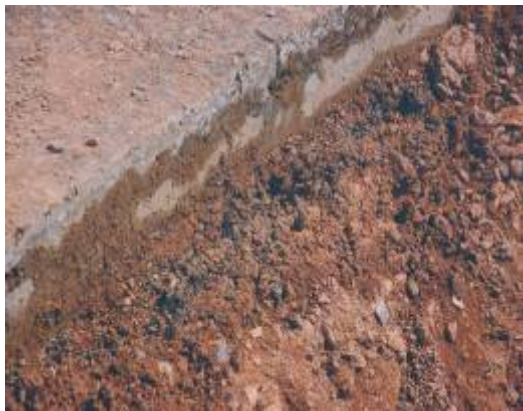
Figure 3: High Moisture content within pavement. Figure 4: Presence of water within pavement.

- Higher moisture content in pits excavated in section 1; (see Figure 3 below)
- Subbase and base course of outer shoulders dry whilst adjacent base course is saturated, as is the subbase below the saturated aggregate base course;
- Free water between asphalt base course and asphalt wearing course layers and between asphalt base course and aggregate base course layers (this was observed during removal of cracked new asphalt layers as well as during sampling for bitumen extraction, both in cracked and uncracked areas; (see Figure 4 below)
- Increasing extent of area of cracking after rainfall;
- Dull appearance of AC samples removed for testing;
- Normal moisture content under pavement of untouched (old) sections and under outer shoulders;

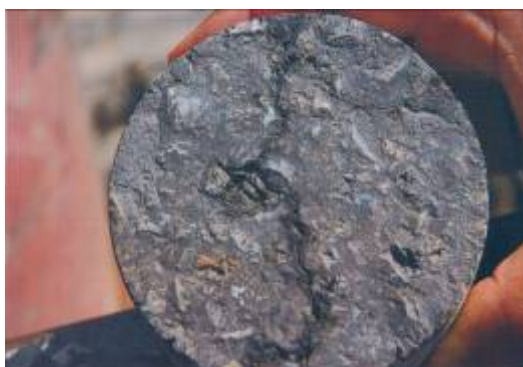
Figure 5: Surface Crack on asphalt core.

A total of fourteen (14) cores were taken, two from each of the distressed sections. From each section one core was taken from a cracked area and another from un-cracked area. The objective of taking cores from both cracked and un-cracked areas was to investigate whether bottom-up or top-down cracking had occurred. The observations made from the cores taken confirmed cracks initiated from the surface of the pavement and propagated downward through the asphalt layer. In some case the cracks were limited only to the top of the wearing course. Others have gone through the wearing course into the top of the asphaltic base course and yet in others the cracks have gone through both the asphaltic wearing and base courses. The observations confirm that “top-down” cracking had generally occurred. (see Figures 5 & 6 below):

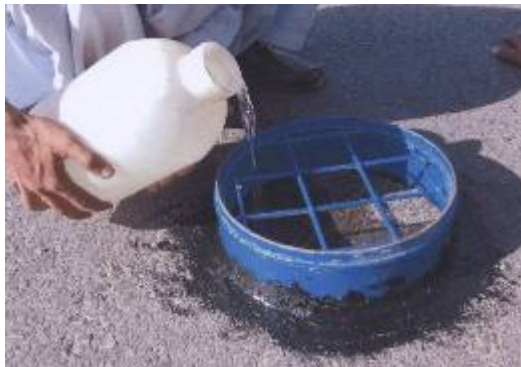
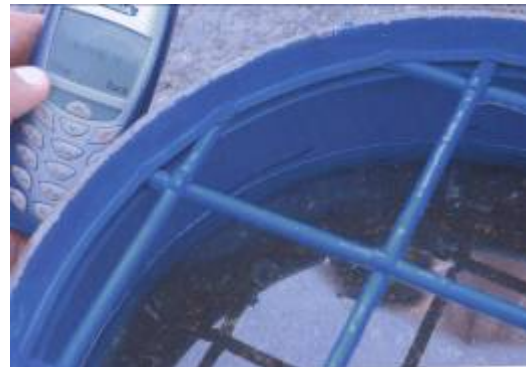
The test consisted of pouring water on a confined area and timing the absorption of the water into the pavement. A 3inch sieve of 30.2 cm diameter was used as the confining device for the water (see Figures 7 and 8 below). This was placed on the pavement and sealed around its outer edges with silicone preventing the escape of water. Water was added up to a preset mark and after 20 minutes the level of water was recorded. The difference between the two corresponding volumes gives the volume of water that has penetrated into the pavement. Four permeability tests were carried out on four sections of the road, namely: On new asphalt concrete wearing course, on new asphalt concrete base course and on old asphalt concrete wearing course (2 tests at different locations). The following are the test results:

- The permeability of the new asphalt concrete wearing course was 0.475 cm/sec (20 minutes for a drop in level of 0.4 cm)
- The permeability of the new asphalt concrete base course was 6.48 cm/sec (2 minutes for a drop in level of 0.4 cm)
- The permeability of existing asphalt concrete wearing course was 0.00 cm/sec (for both tests there was no variation in the water level after 30 mins.)

The degree of porosity of the new mixtures is higher than might have been expected. Whilst the existing asphalt is virtually impermeable (as should be the case since it was an old aged material) with a wearing course, the new mixtures were very porous. That explains why the soils in the pits dug in the existing asphalt were dry whilst those in some of the pits in the new pavement were wet.
